Metropolitan Water Reclamation District of Greater Chicago – 100 East Erie Street Chicago, Illinois 60611-2803 312-751-5600

HANOVER PARK WATER RECLAMATION PLANT FISCHER FARM MONITORING REPORT FOR THIRD QUARTER 2020

Subject: Hanover Park Water Reclamation Plant - Illinois Environmental Protection Agency Permit No. 2016-SC-61315, Monitoring Report for July, August, and September 2020

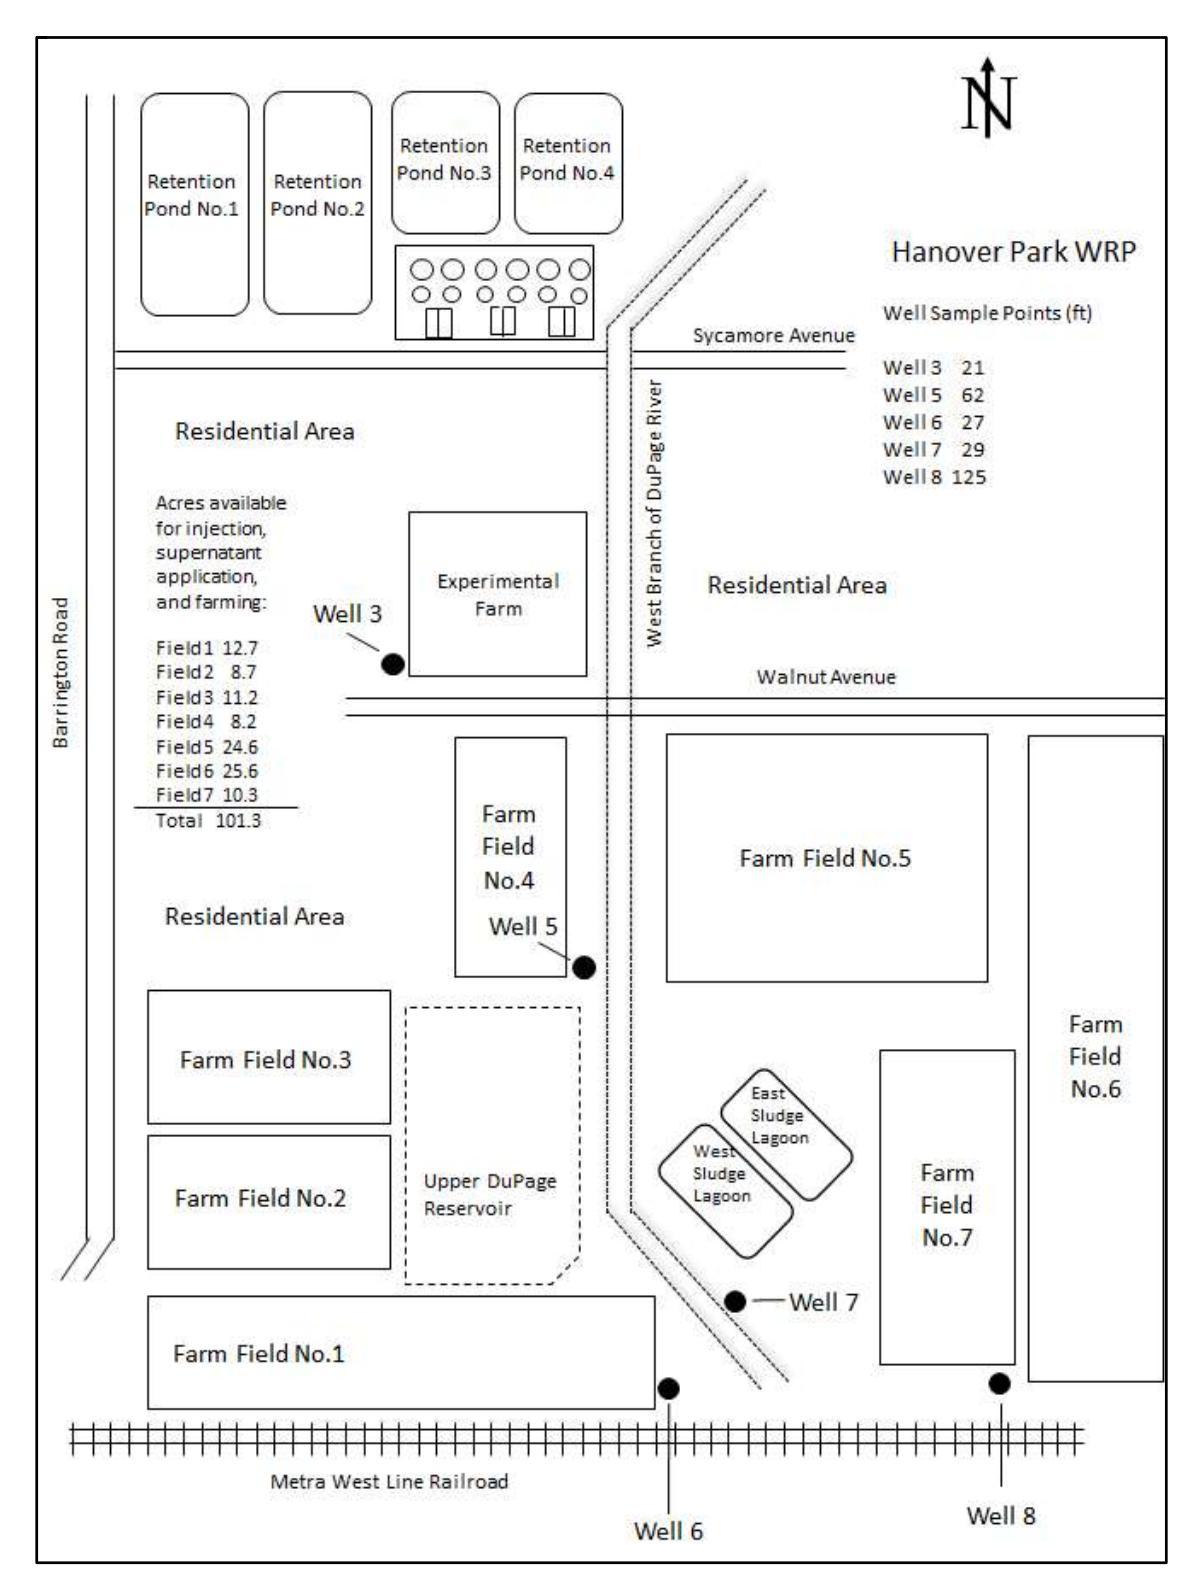
FIGURE 1: MAP OF FIELDS AND WELLS AT THE HANOVER PARK FISCHER FARM SITE OF THE METROPOLITAN WATER RECLAMATION DISTRICT OF GREATER CHICAGO

Drainage water (combined surface and subsurface) returned to the Hanover Park WRP from the farm fields was sampled in July, August, and September 2020, and data for these samples are presented in <u>Table 2</u>. The volumes of drainage water returned to the WRP during the third quarter were estimated as 4.5, 12.5, and 5.0 million gallons in July, August, and September, respectively. The analytical data for lagoon supernatant applied to Fischer Farm fields in July, August, and September are presented in <u>Table 3</u>. The volumes and corresponding dry weights of lagoon supernatant applied are shown in <u>Table 4</u>. Field and water monitoring locations are presented in <u>Figure 1</u>.
