REPORT NO. 22-02

HANOVER PARK WATER RECLAMATION PLANT

FISCHER FARM MONITORING REPORT FOR

FOURTH QUARTER 2021

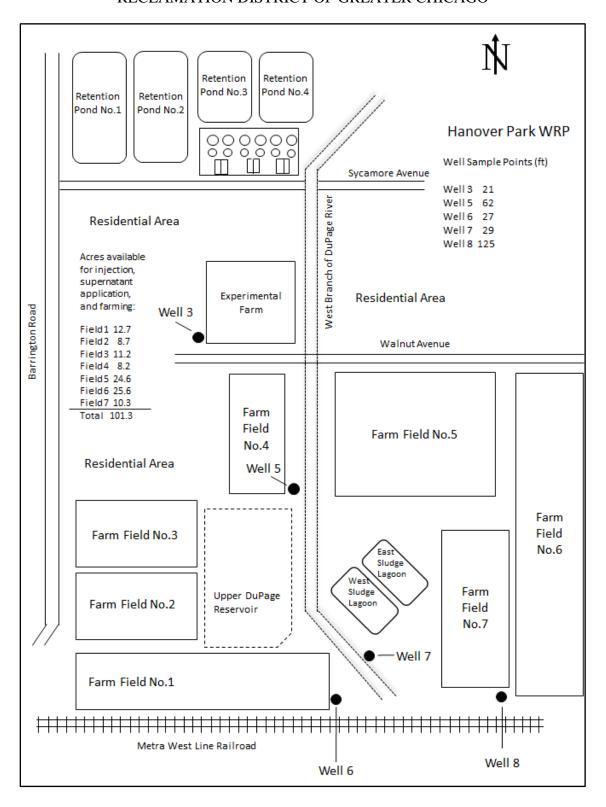
FIGURE 1: MAP OF FIELDS AND WELLS AT THE HANOVER PARK FISCHER FARM SITE OF THE METROPOLITAN WATER RECLAMATION DISTRICT OF GREATER CHICAGO

Drainage water (combined surface and subsurface) returned to the Hanover Park WRP from the farm fields was sampled in October, November, and December 2021, and data for these samples are presented in Table 2. The volumes of drainage water returned to the WRP during the fourth quarter were estimated as 9.1, 16.0, and 13.5 million gallons in October, November, and December, respectively. The analytical data for lagoon supernatant applied to Fischer Farm fields in November are presented in <u>Table 3</u>. The analytical data for liquid biosolids applied to Fischer Farm fields in November are presented in Table 4. The volumes of lagoon supernatant and liquid biosolids, and the associated dry weight of biosolids applied, are shown in Table 5. For the next growing season (2022), corn (Zea mays) will be planted in the fields, except Farm Field Number 7 because no biosolids will be applied to that field. Field and water monitoring locations are presented in Figure 1.
